Company: Orbital Underground Service Location Pty Ltd

Section Inspection - 9/08/2022 - LS163731

Date of inspection 9/08/2022	Work Order No: 4196	Region Brisbane	Operator: Jamie Ware	Section No: 1	Line Segment: LS163731
Type of Sewer: Gravity sewer	Type of Clean: Not cleaned	Direction of CCTV: Upstream	Year laid:	GIS length: 14.00	CCTV Insp length: 12.05

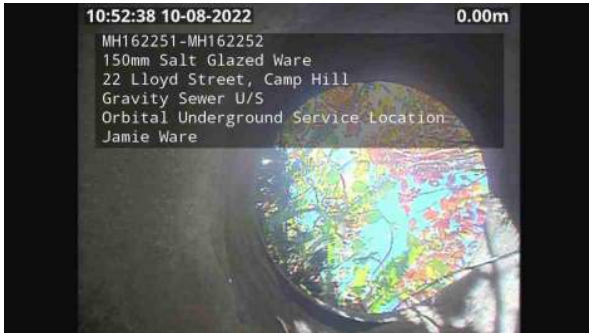
LS163731_2f00863f-889c-4e45-8962-94408b10f2db_20220809_105319_801.jpg, 00:00:00, 0.00
Start node, maintenance hole, Nodename:, MH162251

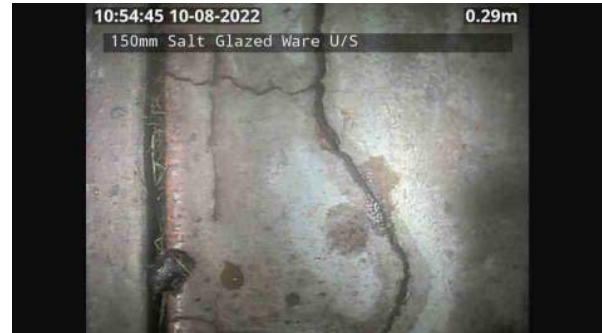
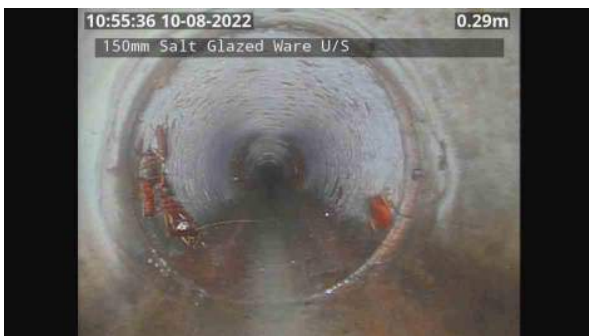
0.29	CMW	Multiple/complex wall crack, at joint, width: 2mm from 12 o'clock to 12 o'clock	00:02:11	LS163731_fddb97a0-3fc1-423e	S 5
	1.81	CMW	Multiple/complex wall crack, at joint, width: 1mm from 4 o'clock to 5 o'clock	00:04:22	LS163731_bb5b977e-913a-46	S 5

LS163731_fddb97a0-3fc1-423e-b3a3-909baecc66eb_20220809_105554_951.jpg, 00:02:11, 0.29
Multiple/complex wall crack, at joint, width: 2mm from 12 o'clock to 12 o'clock

LS163731_ab50eb80-27a0-4926-8f2f-b0f3958cb291_20220809_105617_788.jpg, 00:02:11, 0.29
Multiple/complex wall crack, at joint, width: 2mm from 12 o'clock to 12 o'clock

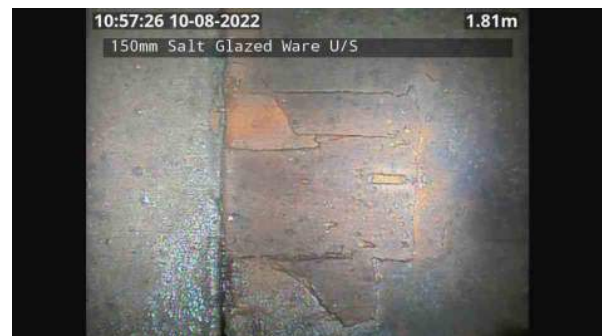
LS163731_bb5b977e-913a-4611-ab69-9c9242840279_20220809_105844_999.jpg, 00:04:22, 1.81
Multiple/complex wall crack, at joint, width: 1mm from 4 o'clock to 5 o'clock

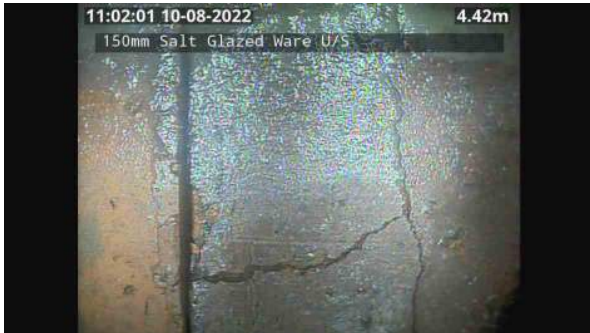
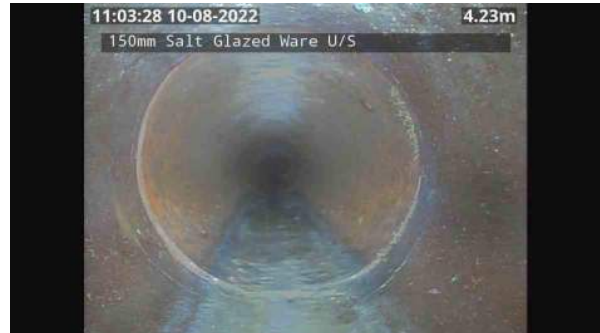
4.42	CMW	Multiple/complex wall crack, at joint, width: 2mm from 12 o'clock to 12 o'clock	00:08:18	LS163731_4899ed5a-411c-4a	S 5
	5.90	RBWB	Roots, at joint at 5 o'clock	00:12:28	LS163731_21a34140-f995-4f1	M

LS163731_4899ed5a-411c-4a0a-9496-ef50f0c96574_20220809_110301_328.jpg, 00:08:18, 4.42
Multiple/complex wall crack, at joint, width: 2mm from 12 o'clock to 12 o'clock

LS163731_d6ff81f3-369f-4d07-92b9-8a8a29aaa666_20220809_110410_133.jpg, 00:08:18, 4.42
Multiple/complex wall crack, at joint, width: 2mm from 12 o'clock to 12 o'clock

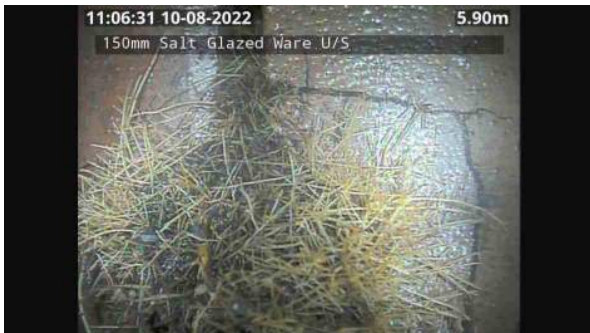
LS163731_21a34140-f995-4f12-b6d7-3720422e5b05_20220809_110746_244.jpg, 00:12:28, 5.90
Roots, at joint at 5 o'clock

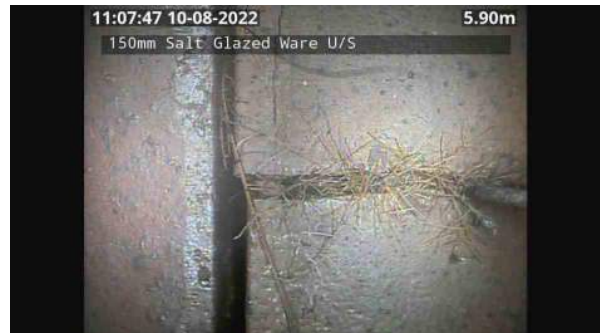
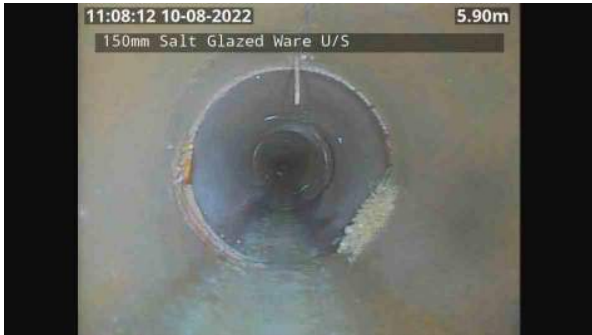
5.90	CMW	Multiple/complex wall crack, at joint, width: 3mm from 12 o'clock to 12 o'clock	00:12:31	LS163731_de50a039-b529-4b	S 5
	6.22	JNGO	Junction open, good workmanship, height: 100mm at 3 o'clock	00:13:18	LS163731_83d94429-23f5-42a

LS163731_de50a039-b529-4bd8-950f-8886be089dc2_20220809_110829_076.jpg, 00:12:31, 5.90
Multiple/complex wall crack, at joint, width: 3mm from 12 o'clock to 12 o'clock

LS163731_33b182b9-f80b-4f3e-a7dc-07076401cc72_20220809_110854_610.jpg, 00:12:31, 5.90
Multiple/complex wall crack, at joint, width: 3mm from 12 o'clock to 12 o'clock

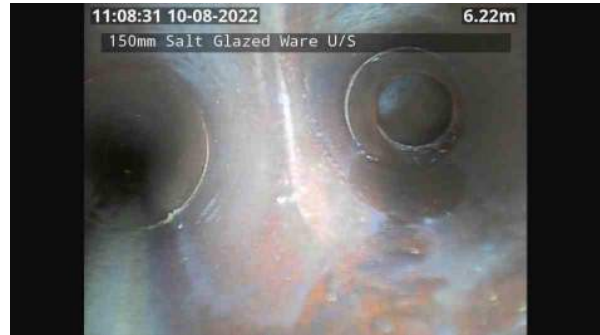
LS163731_83d94429-23f5-42aa-b19c-17e06b1a1b28_20220809_110932_065.jpg, 00:13:18, 6.22
Junction open, good workmanship, height: 100mm at 3 o'clock

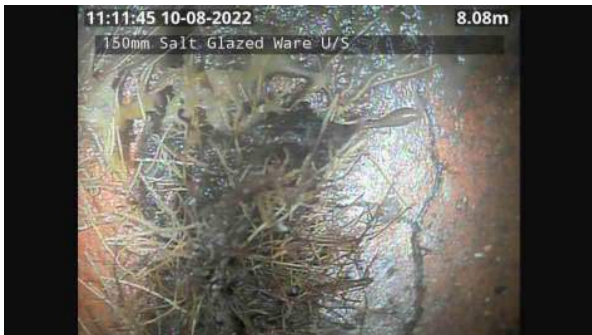
LS163731_3d29be1c-a4cb-4ba1-a4ee-8e62a1ced634_20220809_111243_413.jpg, 00:16:11, 8.08
Roots, at joint at 7 o'clock

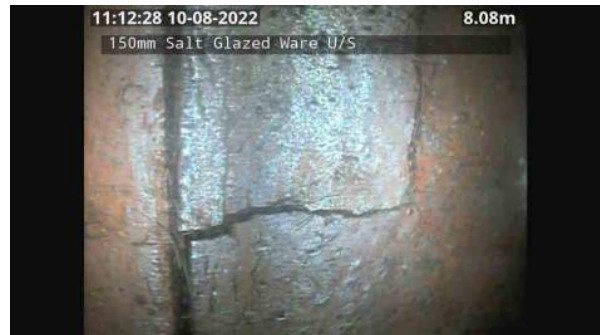
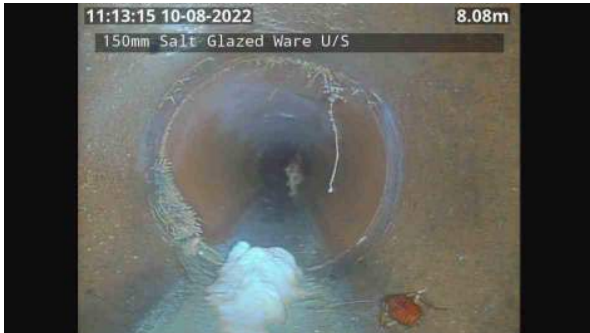
LS163731_cb244404-ceb0-4cba-91de-627f381839de_20220809_111331_281.jpg, 00:16:35, 8.08
Multiple/complex wall crack, at joint, width: 2mm from 12 o'clock to 12 o'clock

LS163731_d0ede370-bea8-4cd3-9b08-c4b84951a1a0_20220809_111356_762.jpg, 00:16:35, 8.08
Multiple/complex wall crack, at joint, width: 2mm from 12 o'clock to 12 o'clock

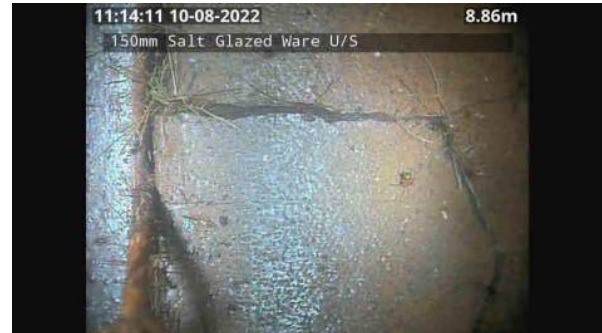
LS163731_49a33510-9e99-411f-b144-f42570773bad_20220809_111513_323.jpg, 00:17:54, 8.86
Multiple/complex wall crack, at joint, width: 2mm from 12 o'clock to 12 o'clock

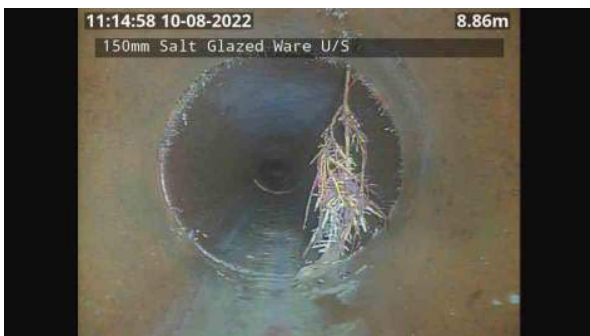
LS163731_21168ccc-f882-41c8-9dfa-e703e0e8c54c_20220809_111603_193.jpg, 00:18:19, 8.86
Roots, at joint from 9 o'clock to 4 o'clock

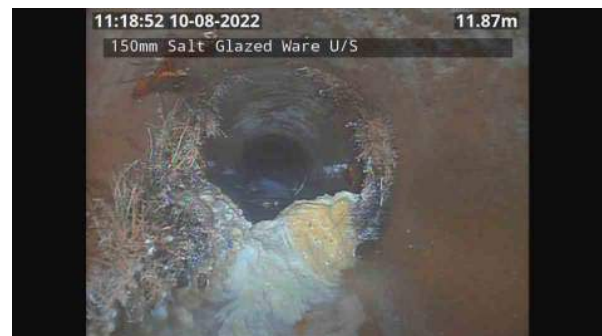
11.87	RBWB	Roots, 4) 20 - 40% of circumference, at joint from 12 o'clock to 12 o'clock	00:21:47	LS163731_fd38a73e-26f2-4cd0	M
	12.05	SAR	Inspection (survey) abandoned, roots	00:23:22	LS163731_6a814c10-38d4-40ef

LS163731_fd38a73e-26f2-4cd0-b5c9-9c1e3bfb4db0_20220809_112002_539.jpg, 00:21:47, 11.87
Roots, 4) 20 - 40% of circumference, at joint from 12 o'clock to 12 o'clock

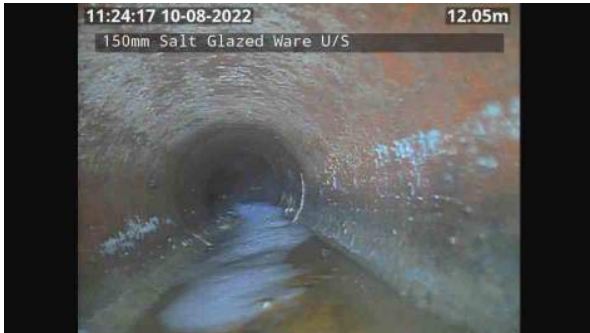
LS163731_6a814c10-38d4-40ef-92d2-83ad5aeb70b3_202208
09_112459_498.jpg, 00:23:22, 12.05
Inspection (survey) abandoned, roots
