## Section Inspection - 11/08/2022 - 1

Date of inspection <b>11/08/2022</b>	Time of inspection <b>13:59</b>	Land Ownership	Pipe Asset ID <b>1</b>	Nr. <b>1</b>
Project name	Contractor's Job Number	Coding Standard <b>WSA 05-2008 2.2</b>	Name of operator <b>Jamie Ware</b>	Job ID <b>4189</b>

Town	US MH <b>MH1</b>	Unit Length <b>0.00 m</b>	
Address	Direction <b>Upstream</b>	GIS length <b>0.00 m</b>	
Location Type <b>Easement</b>	DS MH <b>MH2</b>	Inspected Length <b>12.93 m</b>	
Operation <b>Storm water drain</b>	Use <b>Drain</b>	Year Laid

## Section Inspection - 11/08/2022 - 2

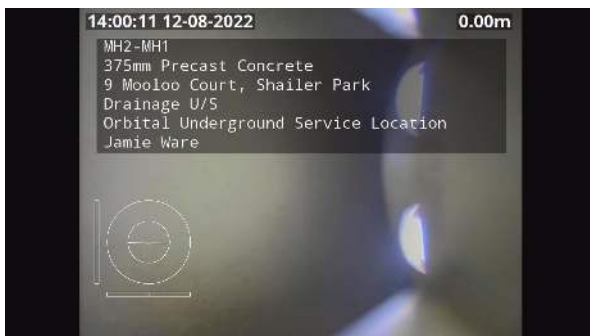
1\_bc7360f2-6c4f-4518-b05d-6f5037d6a297\_20220811\_140054\_291.jpg, 00:00:24, 0.00  
Circumferential wall crack, width: 2mm from 12 o'clock to 12 o'clock

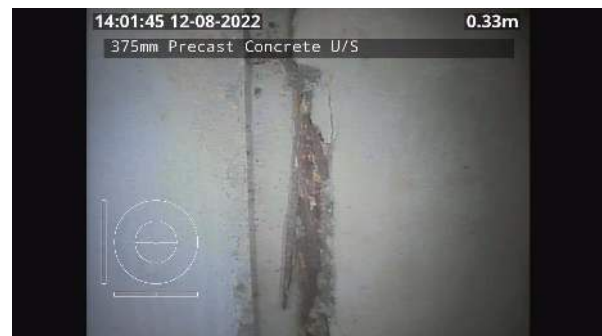
1\_640bf76d-9fac-40bf-b8b1-c9247a7c5d5e\_20220811\_140313\_540.jpg, 00:02:02, 0.33  
Displaced joint, longitudinal displacement, longitudinal displacement: >30mm at 12 o'clock

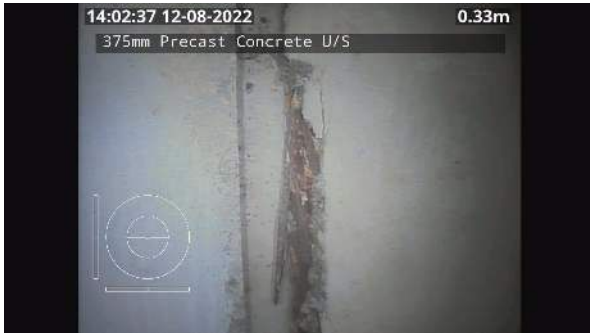
1\_6b540bfc-e687-4be2-911c-c8dc1e484ca1\_20220811\_140459\_056.jpg, 00:02:05, 0.33  
Steel reinforcement is visible and projecting into the conduit, at joint from 9 o'clock to 5 o'clock

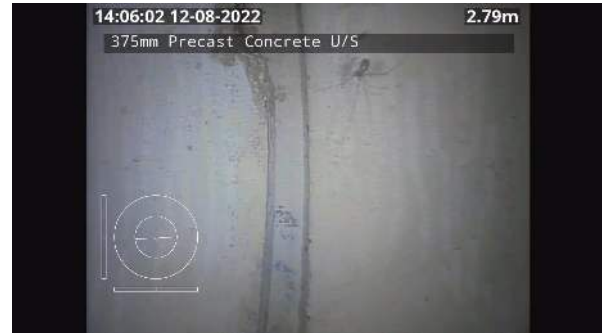
1\_609d39c6-3de4-4952-b427-81ec529ef3f0\_20220811\_140725\_863.jpg, 00:03:48, 2.79  
Displaced joint, longitudinal displacement, longitudinal displacement: >30mm at 12 o'clock

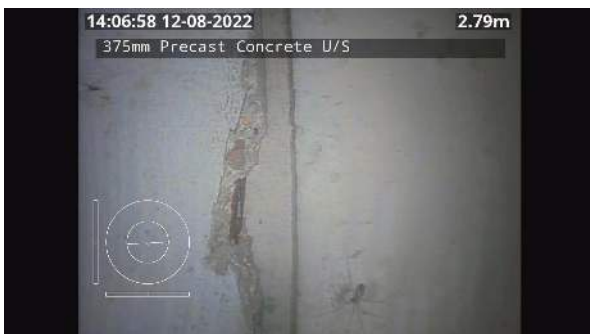
1\_7b1e371c-4a57-4159-8b7e-25aba316bc81\_20220811\_140911\_870.jpg, 00:04:01, 2.79  
Breaking, some pieces are missing, at joint, length of break: 100mm at 2 o'clock / Broken spigot

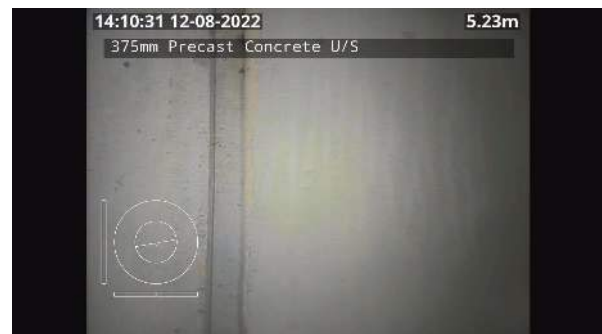
1\_e141f3d4-8ddd-4fb3-a2ac-7b4198ba411e\_20220811\_141132\_172.jpg, 00:06:00, 5.23  
Displaced joint, longitudinal displacement, longitudinal displacement: 21-30mm at 12 o'clock

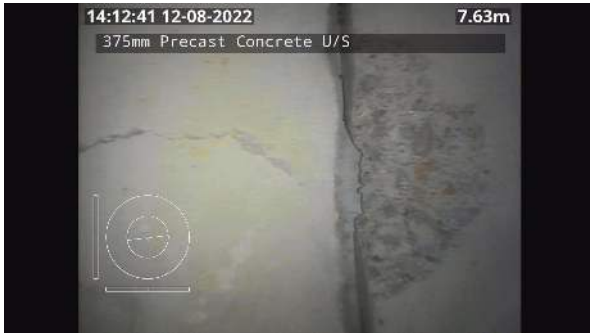
1\_1a7c3295-c7ce-4524-89e3-7b3c108df658\_20220811\_141346\_311.jpg, 00:07:49, 7.49  
Breaking, some pieces are missing, at joint, length of break: 100mm at 9 o'clock

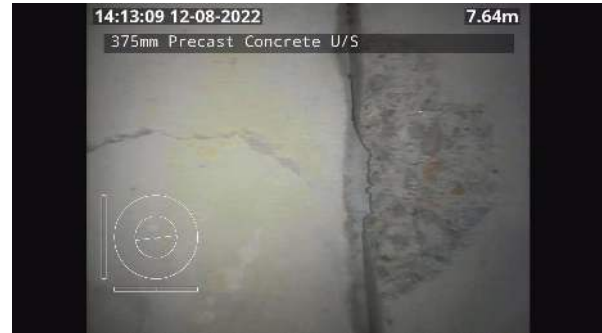
1\_7cc0c38b-218b-4f9a-900d-23252f57c2ed\_20220811\_141420\_824.jpg, 00:07:52, 7.64  
Longitudinal surface crack, at joint, width: 1mm at 9 o'clock

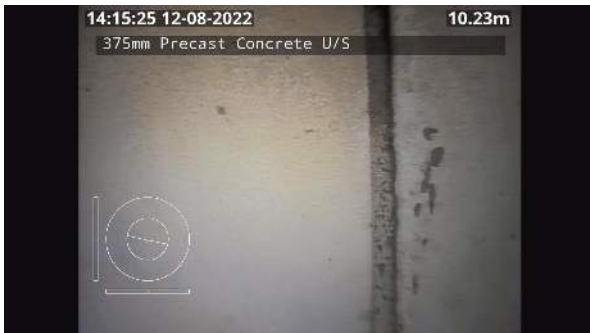
1\_1f983942-07af-46bb-bb51-4a4a8a776d95\_20220811\_141627\_952.jpg, 00:09:06, 10.23  
Displaced joint, longitudinal displacement, longitudinal displacement: 10-20mm at 12 o'clock

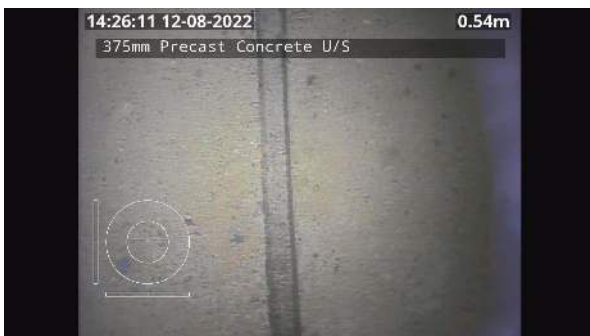
2\_ccad764b-72a3-4b07-8223-4d4b797a7550\_20220811\_142712\_039.jpg, 00:01:58, 0.54  
 Displaced joint, longitudinal displacement, longitudinal displacement: 10-20mm at 12 o'clock

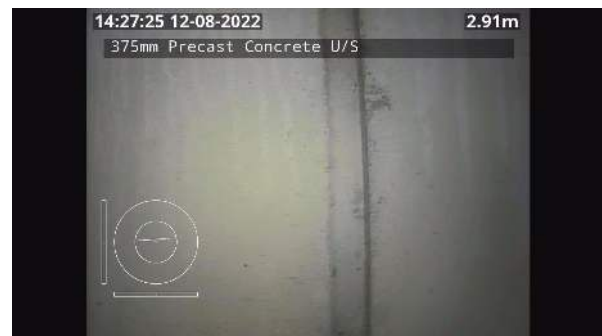
2\_a5729d3b-4510-4955-8516-465be0dd0164\_20220811\_142822\_015.jpg, 00:02:52, 2.91  
 Displaced joint, longitudinal displacement, longitudinal displacement: 10-20mm at 12 o'clock

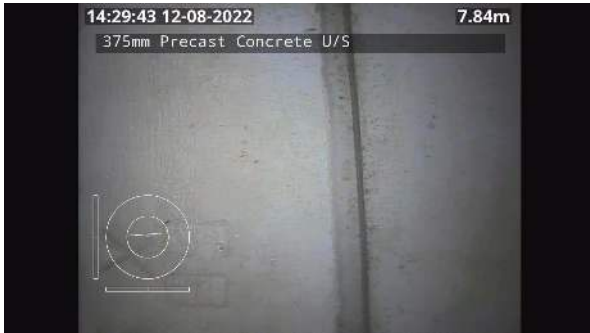
2\_84634ada-02b3-4ee7-84fd-36fca8b637e2\_20220811\_143040\_353.jpg, 00:04:55, 7.84  
Displaced joint, longitudinal displacement, longitudinal displacement: 10-20mm at 12 o'clock

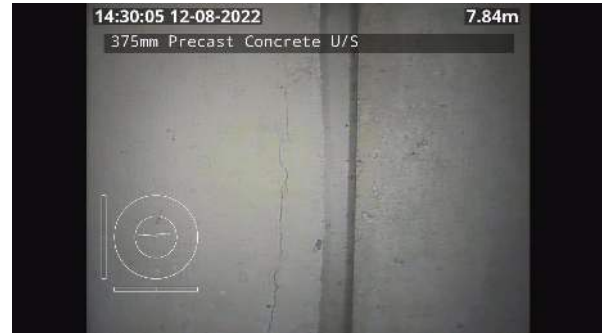
2\_86d8aeb3-9bf2-4faa-9b34-8e133b939c95\_20220811\_143110\_651.jpg, 00:05:01, 7.84  
Circumferential wall crack, at joint, width: 1mm from 11 o'clock to 1 o'clock
