## Section Inspection - 11/08/2022 - 1

Date of inspection <b>11/08/2022</b>	Time of inspection <b>13:59</b>	Land Ownership	Pipe Asset ID <b>1</b>	Nr. <b>1</b>
Project name	Contractor's Job Number	Coding Standard <b>WSA 05-2008 2.2</b>	Name of operator <b>Jamie Ware</b>	Job ID <b>4189</b>

Town	US MH <b>MH1</b>	Unit Length <b>0.00 m</b>	
Address	Direction <b>Upstream</b>	GIS length <b>0.00 m</b>	
Location Type <b>Easement</b>	DS MH <b>MH2</b>	Inspected Length <b>12.93 m</b>	
Operation <b>Storm water drain</b>	Use <b>Drain</b>	Year Laid

## Section Inspection - 11/08/2022 - 2

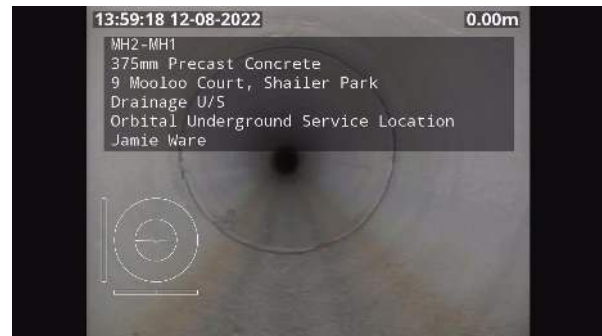
1\_46e48fd8-da88-43c9-87d2-15a080f03879\_20220811\_140009\_964.jpg, 00:00:22, 0.00  
Water level, clear flow (the invert is visible), water level: 0%

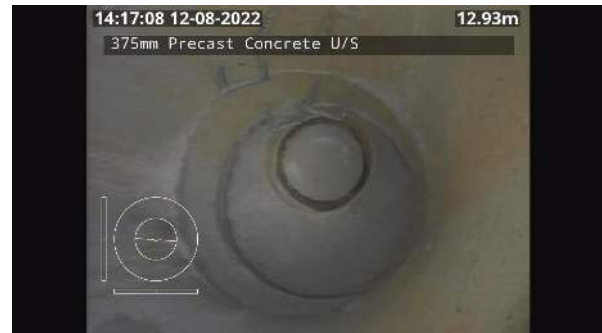
1\_1d845ed1-0190-4290-b800-888ec4aacf67\_20220811\_141751\_201.jpg, 00:10:10, 12.93  
Finish node, maintenance hole, Nodename:, MH1

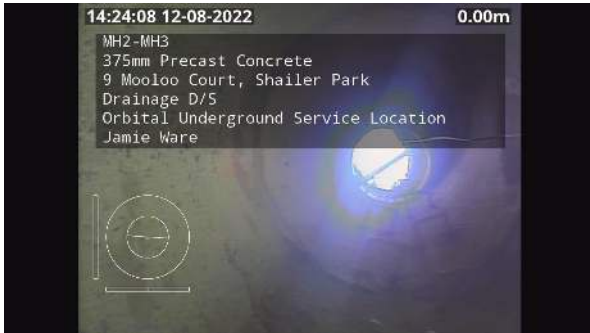
2\_a1ccb371-f6f2-41b6-9916-f0905a8550a7\_20220811\_142450\_746.jpg, 00:00:00, 0.00  
 Start node, maintenance hole, Nodename:, MH2

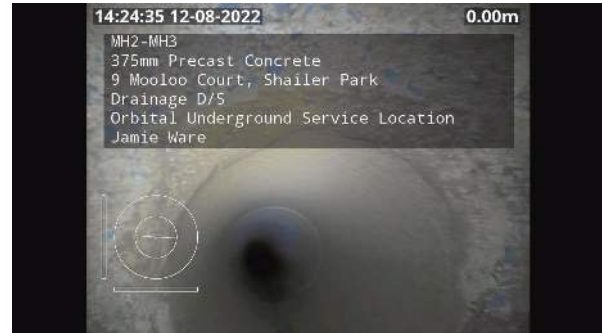
2\_522194c7-3e11-41cb-ae8a-98216a695492\_20220811\_142517\_563.jpg, 00:00:18, 0.00  
 Water level, clear flow (the invert is visible), water level: 0%

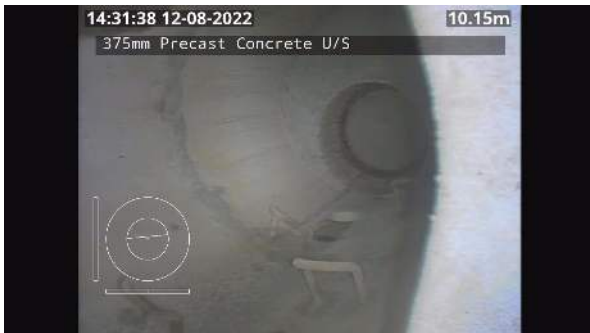
2\_8575c63a-614f-48f5-8620-7e83d79b1442\_20220811\_143220\_680.jpg, 00:05:54, 10.15  
Finish node, maintenance hole, Nodename:, MH3
